Detection of Defects in C/C Composite Aircraft Brake Disks by Using ACUT

Anish Poudel, Tsuchin Philip Chu

Department of Mechanical Engineering and Energy Processes, Southern Illinois University, Carbondale, Illinois 62901

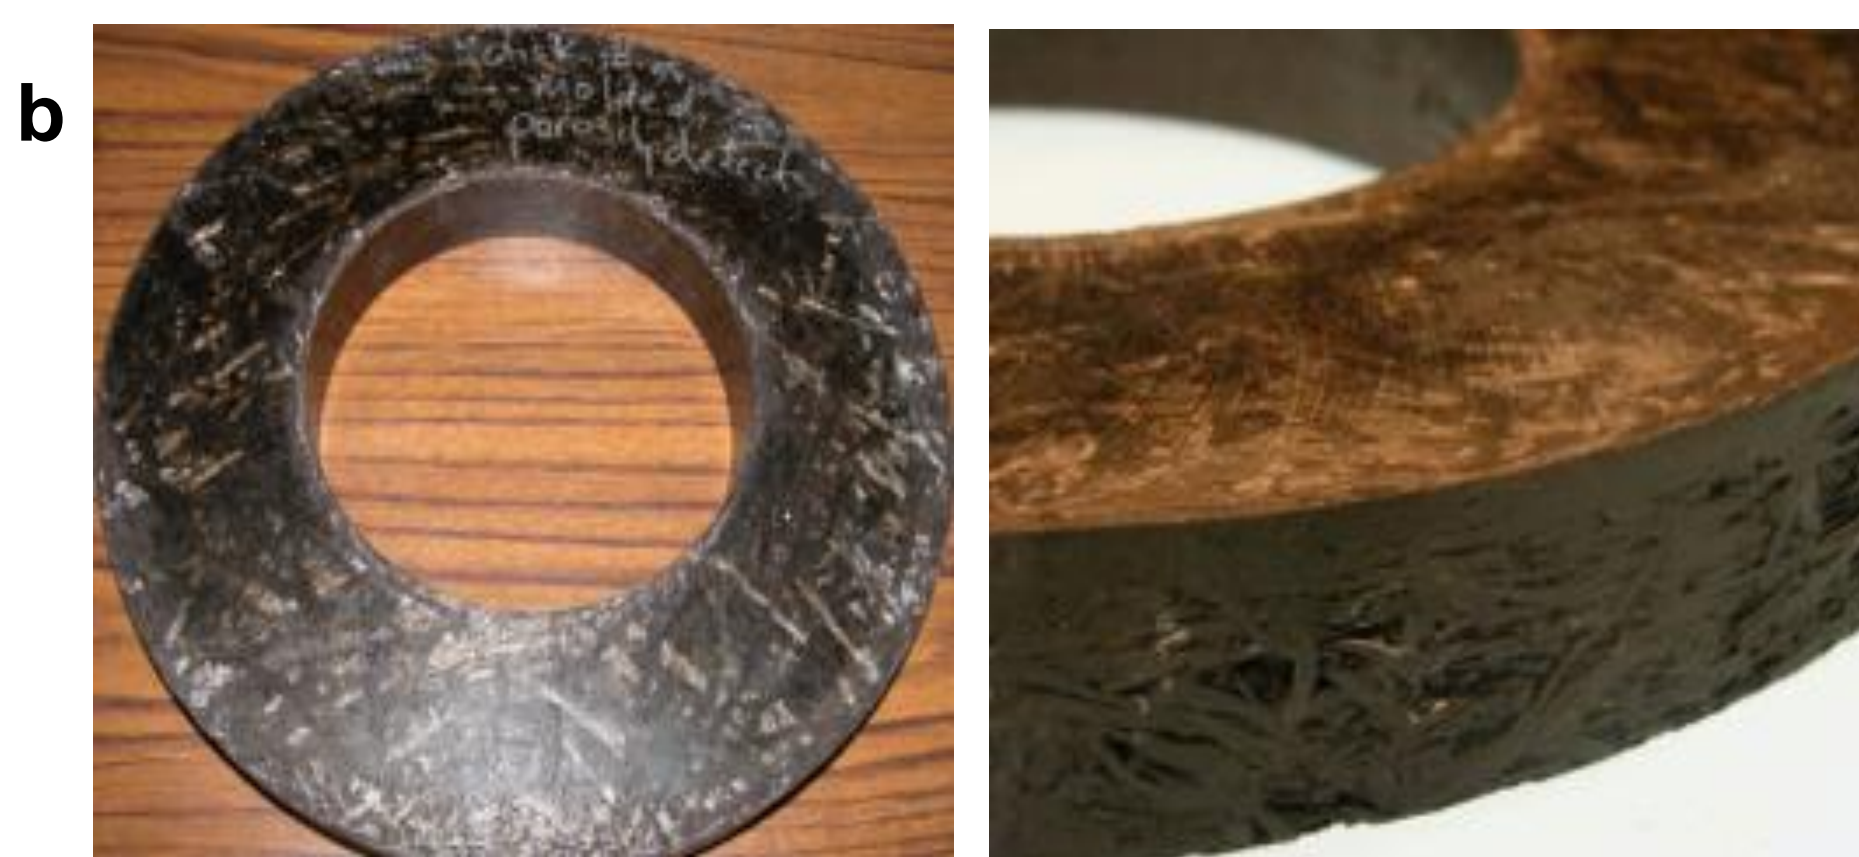
- Commercial C/C composite resin as-molded brake disks
- Prepared by hot pressing chopped carbon fibers in phenolic resins
- Diameter of 292 mm and thickness of 33 mm
- Large porosity defect visible

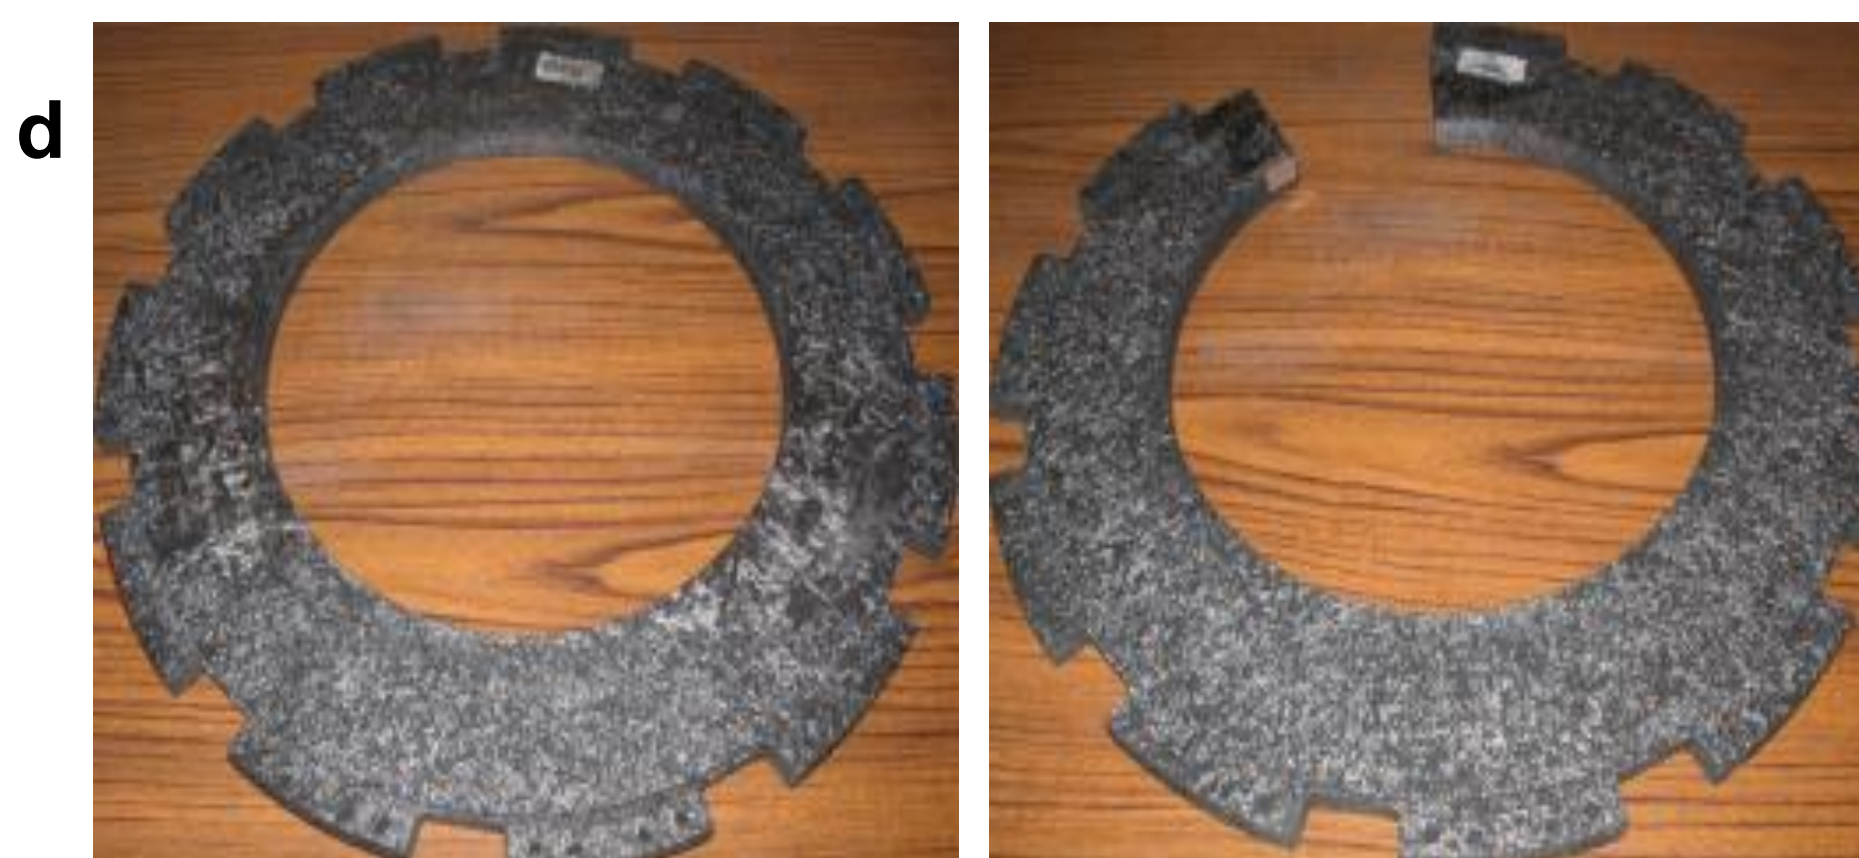
- Honeywell heat treated (HT) C/C composite aircraft brake disks
- Did not have any visible defects
- Diameter of 476.2 mm and thickness of 23.5 mm

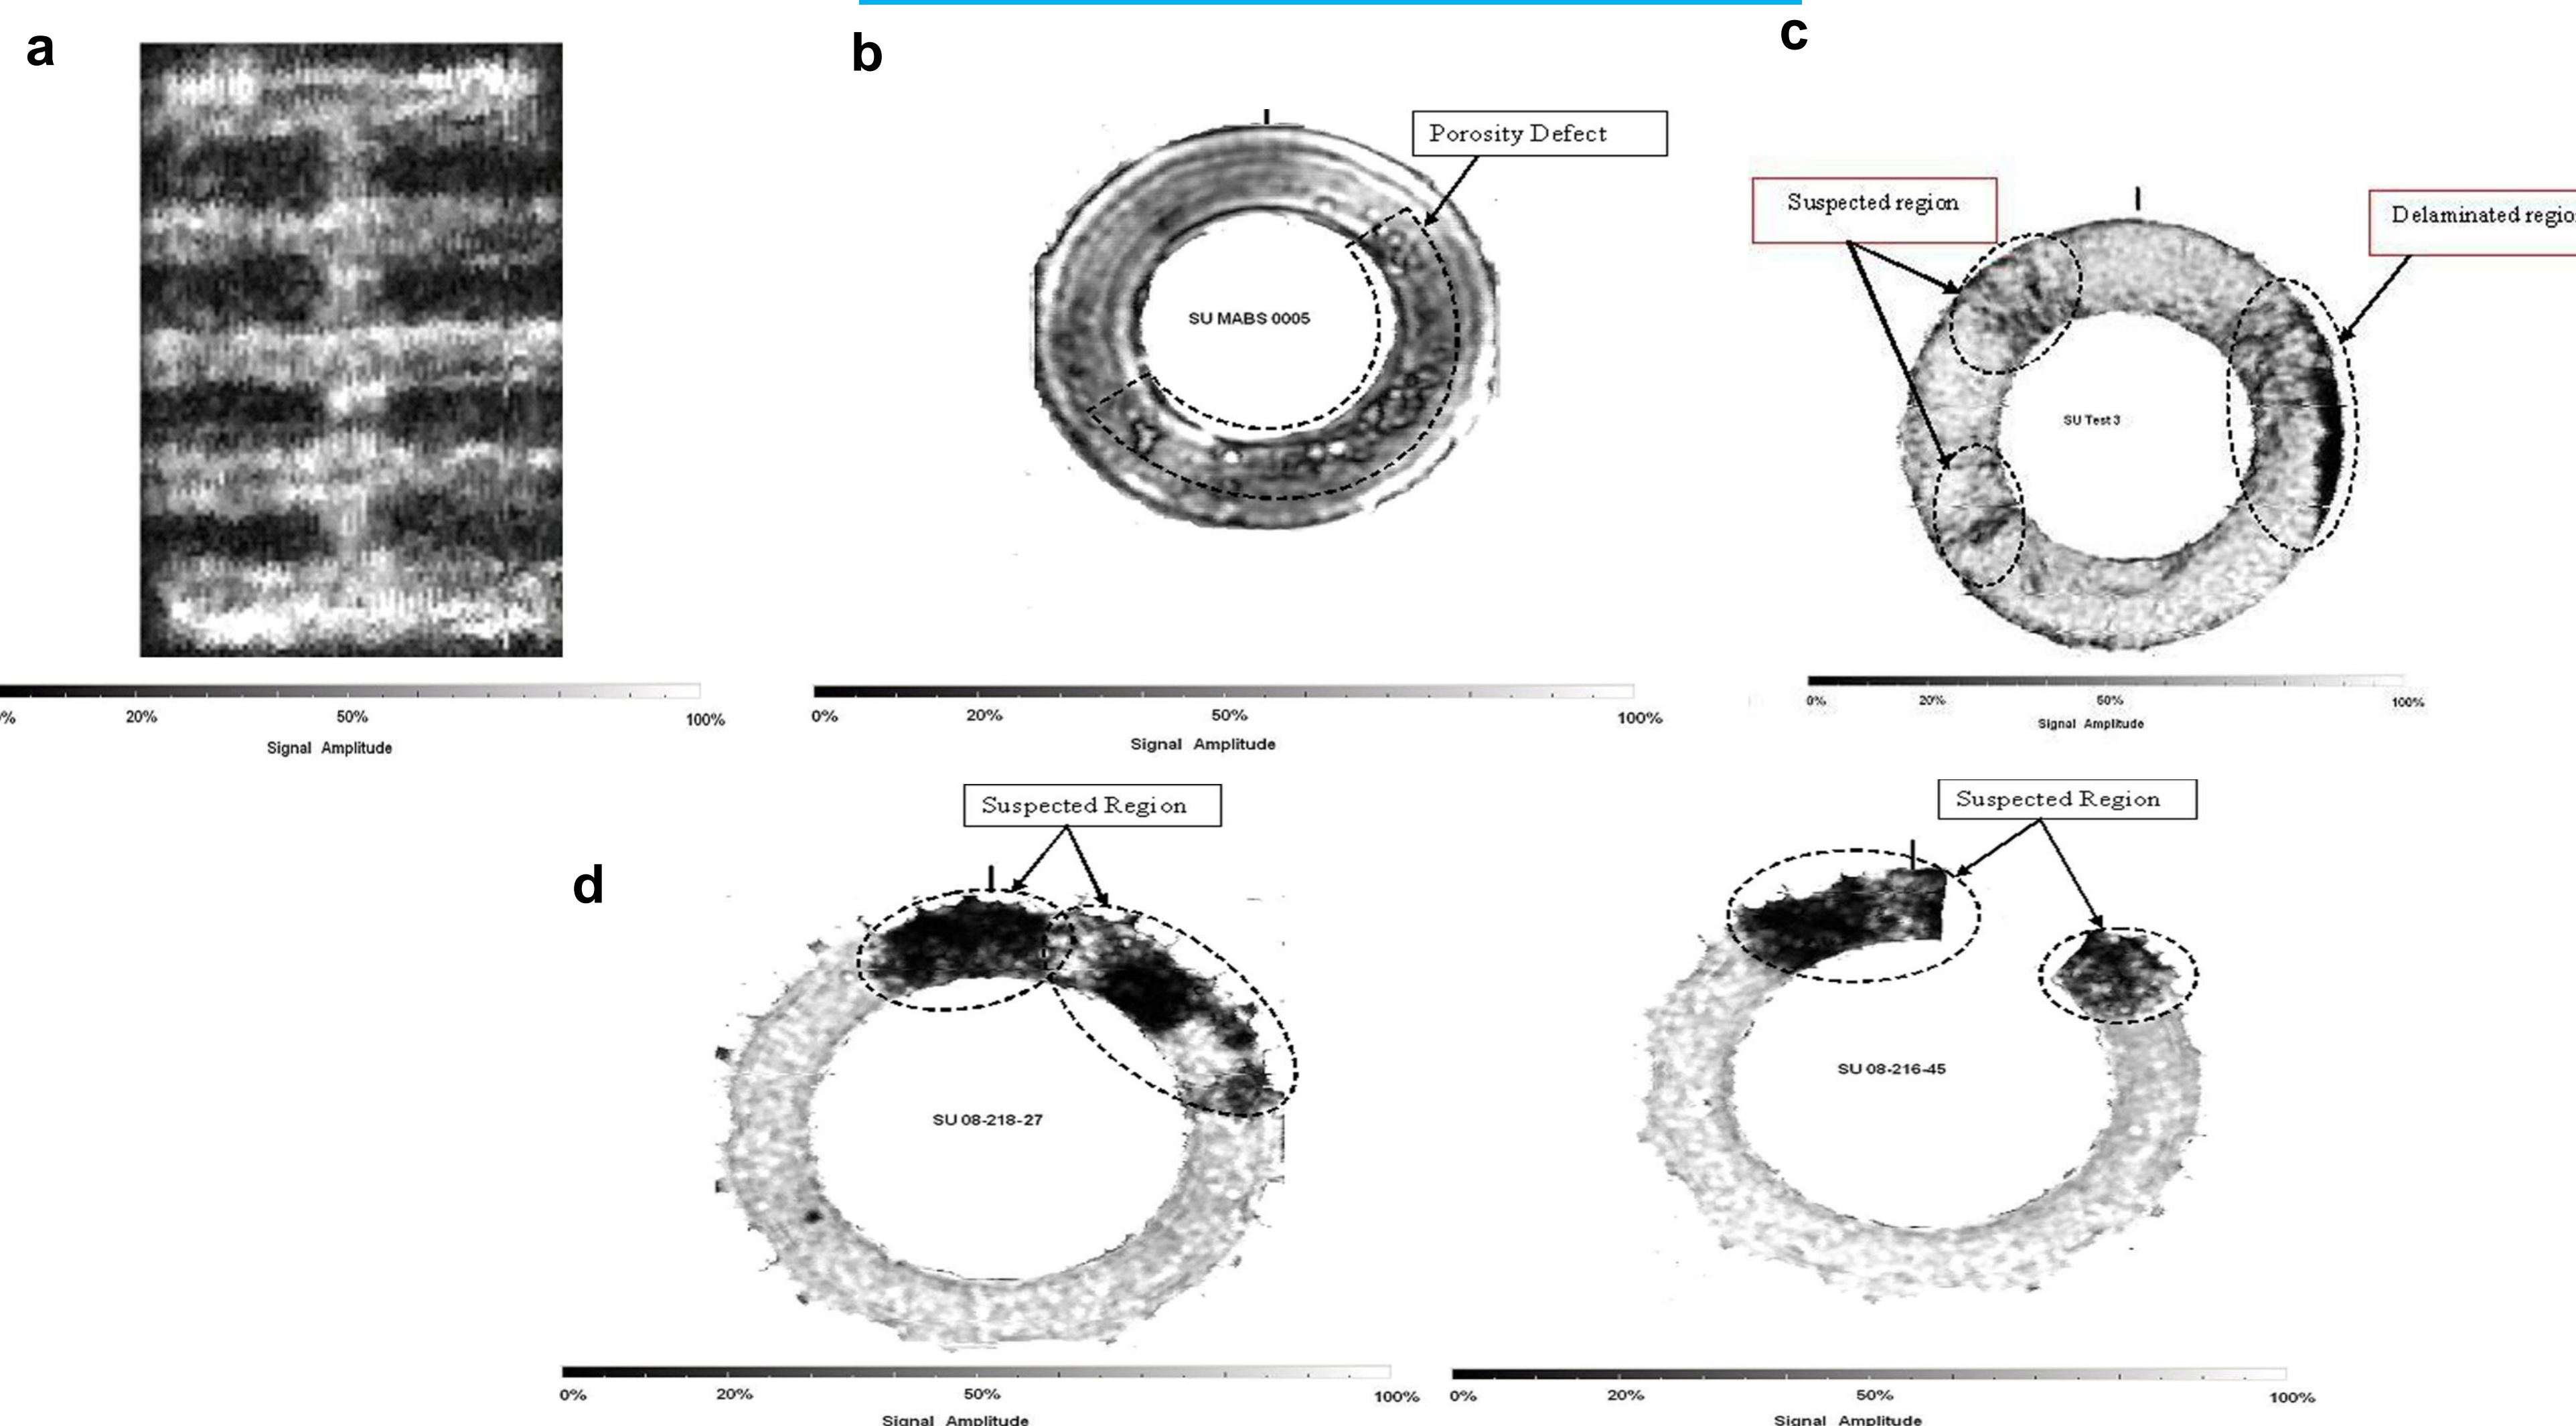
C-scan Amplitude Image Results for Carbon-Carbon Composite Brake Disks

- The C-scan ACUT results revealed the embedded and visible defects in all commercial aircraft brake disks.
- Defect areas are represented by dark shade of grey colors which reflect 0% signal amplitude.
- Artificial defects were also clearly detectable in the C-scan image results of 125 kHz.
- Suspected regions may be the regions with embedded defects, delaminations, foreign materials, high porosity or may have been caused by carbon fiber orientation which further needs to be quantified.
- Calibration is essential for each ACUT measurement.
